California Levee Vegetation Research Program

Influence of Tree Roots and Mammal Burrowing Activity on Levee Integrity:

Volume 4. – Field Evaluation of Burrowing Animal Impacts and Effectiveness of Remedial Measures

Geotechnical Engineering
University of California, Berkeley
Report UCB GT 13-03 vol. 4

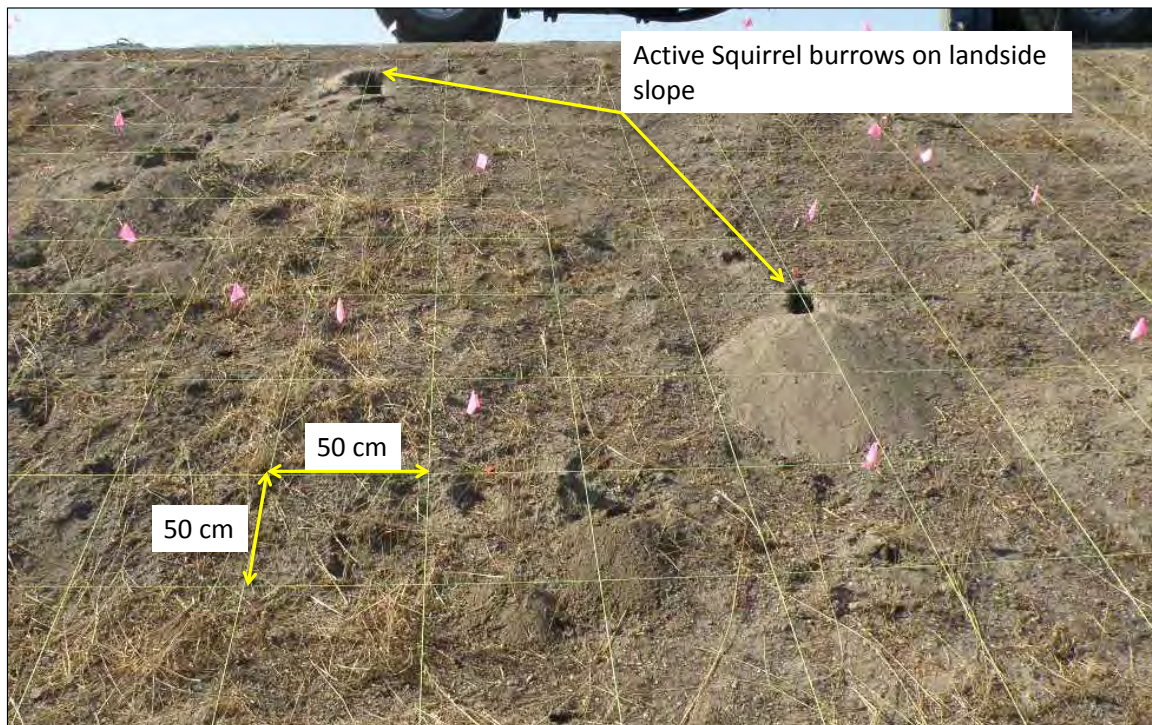
On the landside slope (Figure 3-2), several large active burrows were observed mid slope and towards the levee crown, with ‘porches’ of ejected material exceeding one meter in downslope length. Typical active burrow diameters ranged between 8 and 20 centimeters (0.3 and 0.7 ft), indicating the burrowing species was ground squirrel, which was confirmed later when several ground squirrels were observed emerging from nearby burrows. The upper bound of the diameter appears to be large for the common California ground squirrel, and can be explained by the fact that the levee material lacks cohesion or cementation and collapses easily, therefore the large size of some holes is likely due to re-digging of previously smaller burrows (Van Vuren, 2012).

Figure 3-2. Typical active California ground squirrel burrows on landside slope of the sandy levee

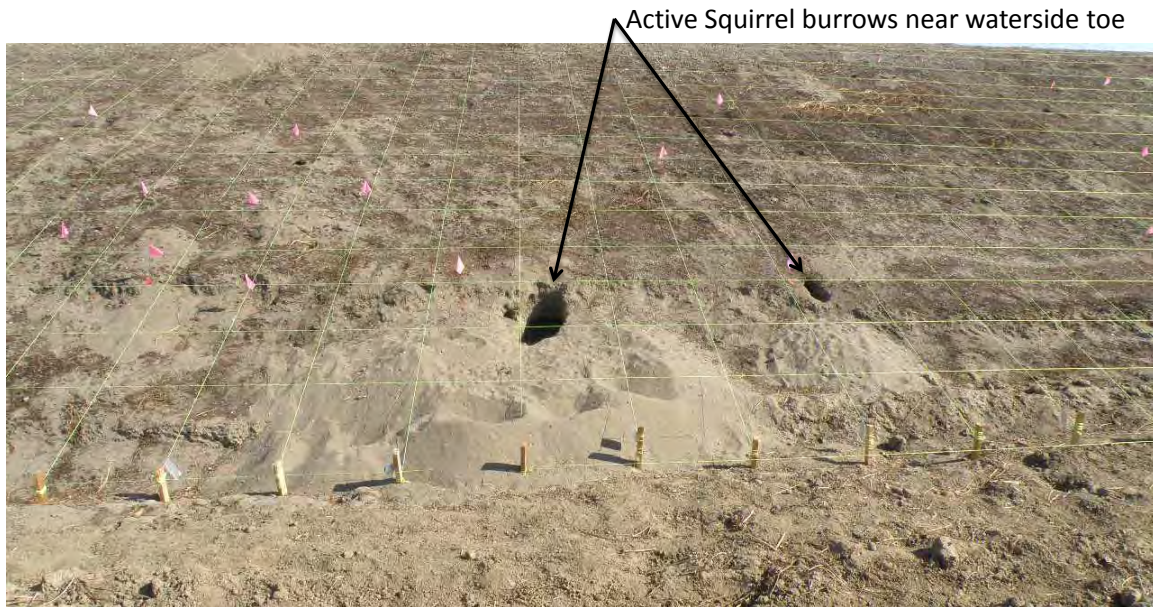
Figure 3-3. Largest active California ground squirrel burrows on waterside slope of the sandy levee

Figure 3-3 shows a view of the main burrows on the waterside slope. Two large burrows with an entrance diameter between 20 and 30 centimeters (0.7 and 1 ft) were observed near the waterside toe, and showed a large cone of ejected material. Other burrows along the waterside slope were generally small or inactive. Seventy two burrows were surveyed on the landside slope; thirty four burrows were encountered on the waterside slope, and six along the crown of the levee. The marked difference between landside and waterside slope is likely attributable to the proximity of the food source to the landside slope, and to layering of the levee embankment. The surveyed holes are indicated by pink flags on Figure 3-2 and Figure 3-3, and are shown in plan view on Figure 3-4. The plan view shows active ground squirrel burrows and all other holes where no differentiation of activity and species could be made because of recent burning of the levee slopes, which might have removed the material from the porches, and partially or completely collapsed some holes.

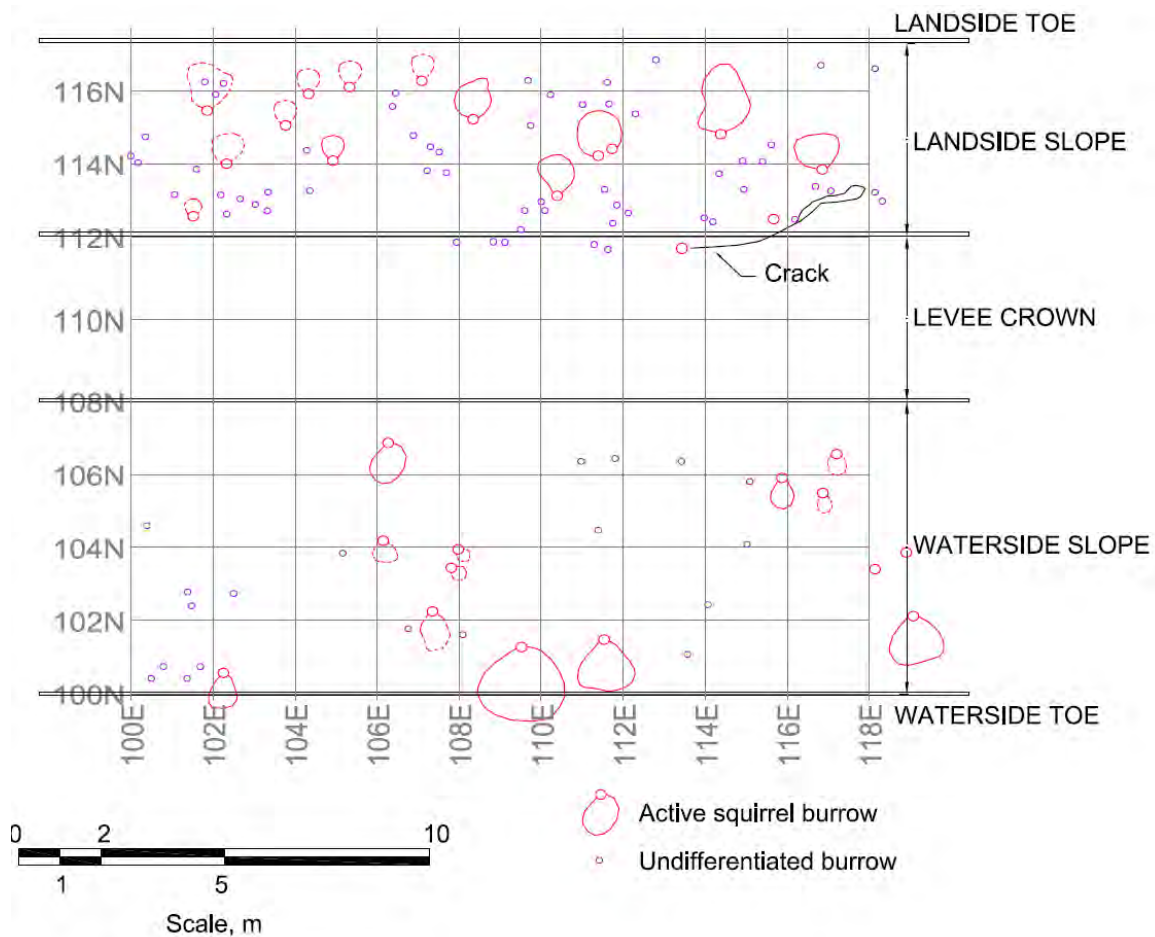
A burrow was classified as active based on the presence of material ejected downslope of the entrance, food waste and/or footprints in the vicinity of the entrance. A total of 14 active ground squirrel holes were surveyed on the landside slope, one on the crown near the landside hinge point and six on the waterside slope. Inactive burrows showed a similar trend; 58 inactive or collapsed holes were observed on the landside slope, while 19 were found on the waterside slope.

Figure 3-4. Plan view of surveyed burrows at the sandy levee site

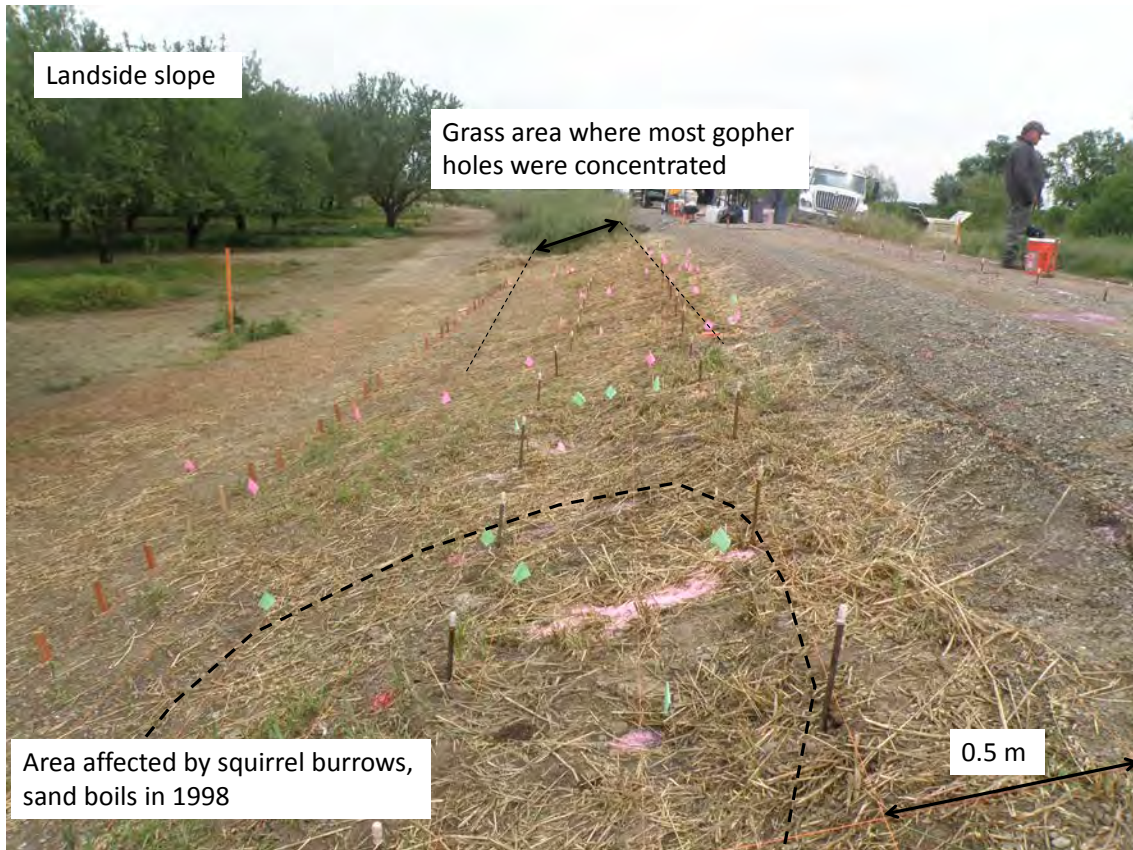
4-4 shows the landside slope prior to excavation, indicating the location of burrows and one of the sandbag rings shown on Figure 4-2d.

Figure 4-4. Location of burrows on landside slope of the clayey levee. Pink flagging indicates location of undifferentiated burrows, green flagging indicates burrows historically grouted with cement-bentonite by DWR.

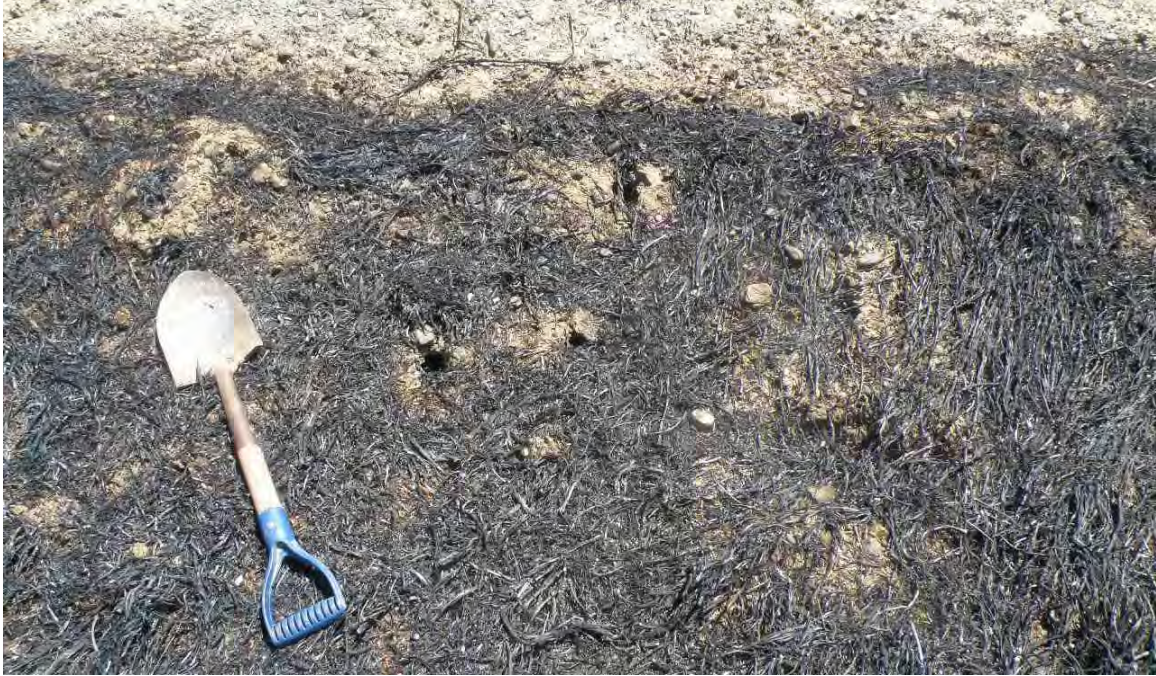
Similar types of intrusions were observed on the waterside slope, with most burrows concentrated on the upper half of the slope (Figure 4-5). In contrast with the sandy levee site, the few remaining ejected soil ‘porches’ were composed of chunks of clay and few gravel particles, representative of the material composing the levee embankment. Surveying activities were performed in similar fashion as described for the sandy levee, but differentiation of active and inactive holes was more challenging on this site because of the previously mentioned mowing and burning. A plan view of identified burrows is shown on Figure 4-6. Twelve active California ground squirrel burrows were encountered along the 20-meter long test section; fifty-two unidentified burrows were logged on the waterside slope, and seventy such holes on the landside. Based on conversations with Dr. Dirk Van Vuren of UC Davis, most of these small unidentified holes were classified as Pocket gopher holes. The urethane grout injection plan (Figure 4-7) included seventy-five ports distributed in a grid pattern and spaced at 1.2 meters (four feet).

Figure 4-5. Typical California ground squirrel burrows on waterside slope of the clayey levee

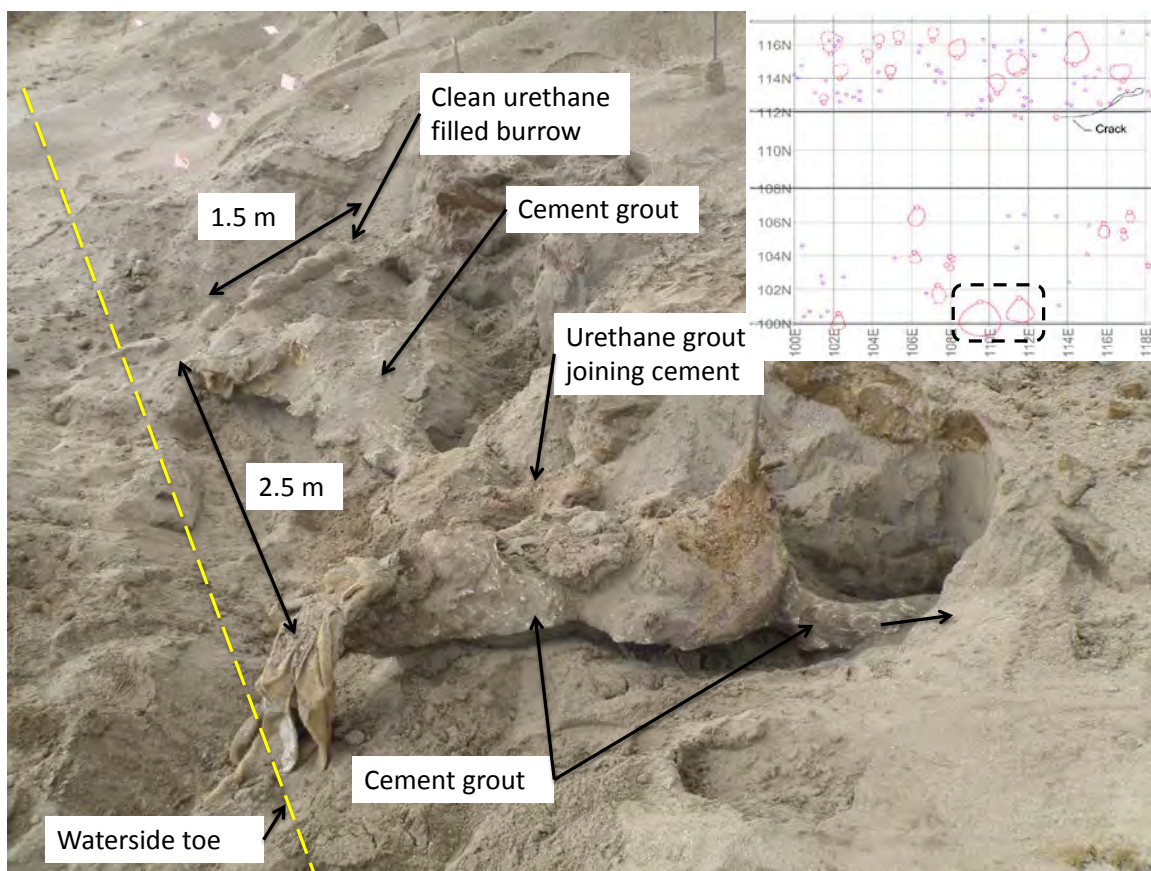
As noted above, a single large burrow was encountered on the waterside slope, approximately one meter above the levee toe. This burrow extended parallel to the toe between the two large active openings shown on Figure 3-3 and had two main arms extending into the levee. Figure 5-1 shows the initial excavation of this burrow, which extended approximately 2.5 meters in the direction parallel to the toe and was mostly filled with cement-bentonite grout between the two burlap bags indicating the cement based grout injection points, except for a 40 centimeter (1.3 ft) segment filled with polyurethane that seemed to join the ends of the cement-bentonite grout. A 1.5 meter (5 ft) urethane-filled burrow was encountered to the western end (upper left side of Figure 5-1) of this system, extending approximately normal to the levee toe alignment. Finally, the largest and more important component of this burrow system was observed near the eastern edge of the burrow (bottom right of Figure 5-1), where a large diameter burrow mainly grouted with cement extended from the burlap bag approximately 2 meters (6.6 ft) into the levee with an average diameter of 40 centimeters.

Figure 5-1. Exposed burrow system near waterside toe of the sandy levee

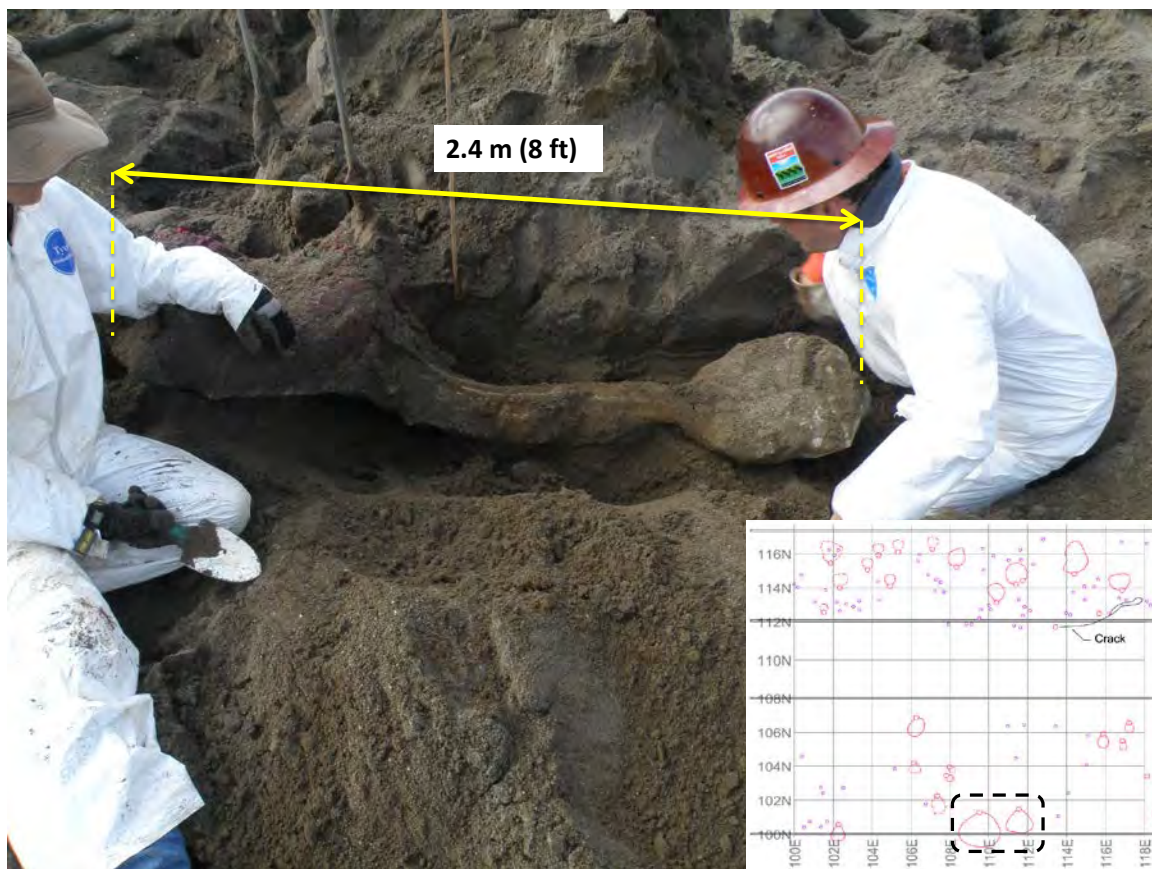
Figure 5-2. Continuation of waterside burrow into the levee on the sandy levee

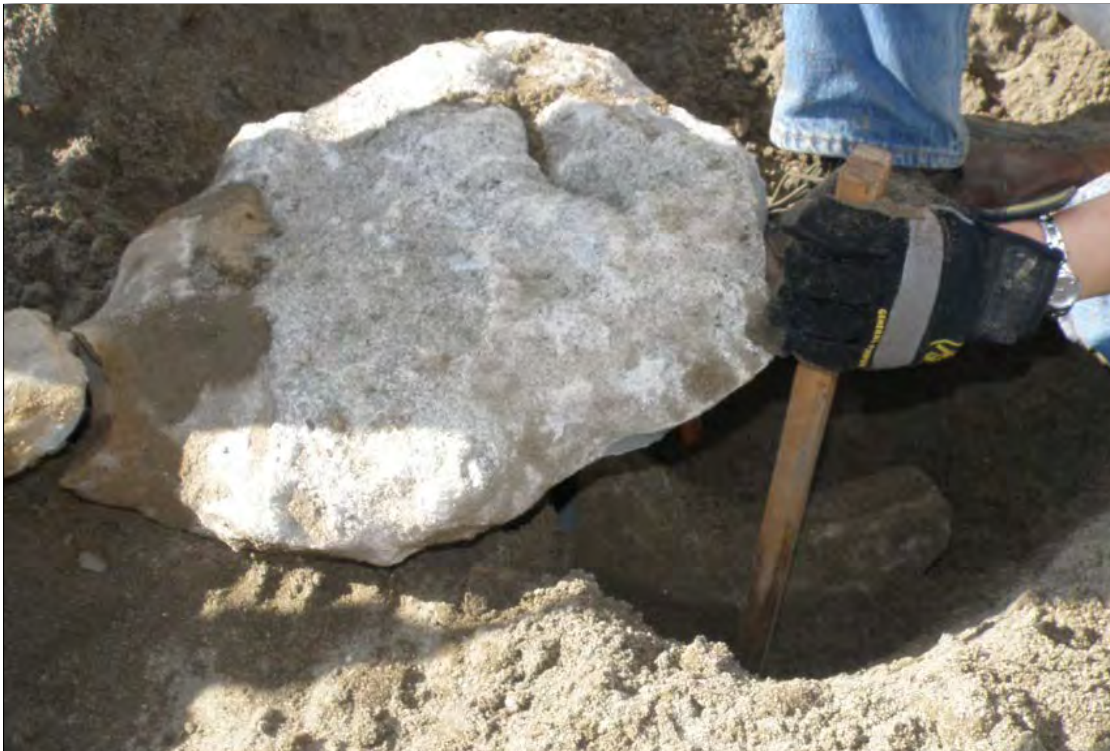
centimeter long tunnel was observed extending below the den (Figure 5-3), which could have been used as a disposal for droppings by the burrowing animal (Van Vuren, 2012).

The extent of the main burrow and den coincided with the interface between the silty material and the loose sand composing the majority of the levee, as the stiffer fine grained soil would provide a stable roof for the burrow, dug by an animal efficiently digging inside the loose sand. This observation was consistent several burrows at this site. Other burrows were observed to have been dug in the fine grained layer.

Figure 5-3. Close up of den (grout mass) near waterside toe of the sandy levee. The wooden stake points to a short burrow below the den.

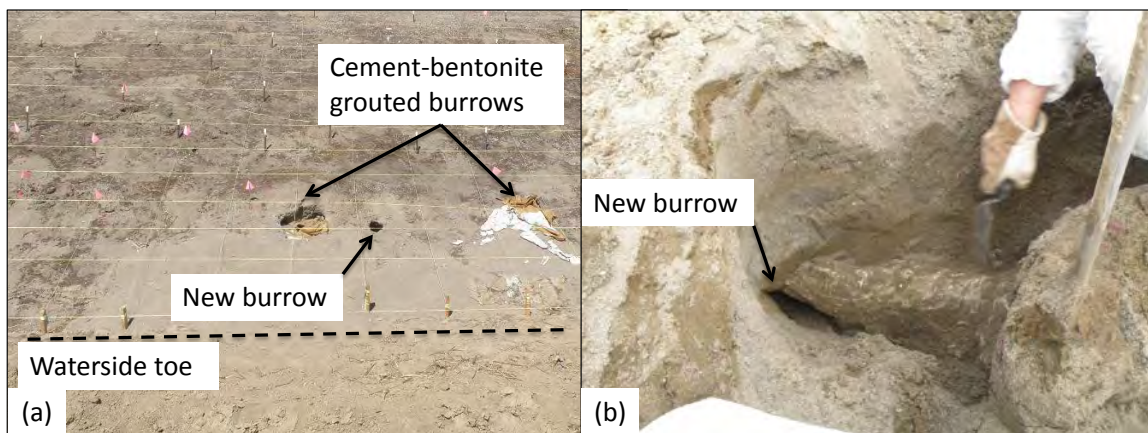
Evidence of the persistence of burrowing activities was observed during the grouting on the site: sometime during the two weeks between the end of the cement-bentonite grouting and the start of the polyurethane grouting programs, a new hole was observed between the two large active burrows near the waterside toe shown on Figure 3-3. Excavation revealed that this new hole followed the previously grouted linear burrow into the levee and likely reached the disc-shaped den; but it is unclear whether it was created as a new burrow or if it as dug was an escape route by an animal trapped in the adjacent grouted tunnel. Figure 5-4a shows the location of the new burrow entrance relative to the previously grouted large burrows, and Figure 5-4b is a close up of the 10 centimeter-diameter (0.3 ft) ungrouted new burrow below the cement grouted burrow.

Figure 5-4. New hole after cement-bentonite grout on waterside toe of the sandy levee Site. (a) shows the location of the new burrow and (b) shows the partially excavated open burrow below the cement-grouted main tunnel.

Another key observation from the sandy levee site is the persistence of burrowing activities; as shown on Figure 5-4, a new burrow was dug between the two large burrows near the waterside toe after the cement-bentonite grout was injected, and followed the alignment of the grouted burrow. Furthermore, during a field visit several months after the test was completed and the levee had been rebuilt, new burrows were observed within the repaired levee section (Figure 7-2) and on the landside berm.

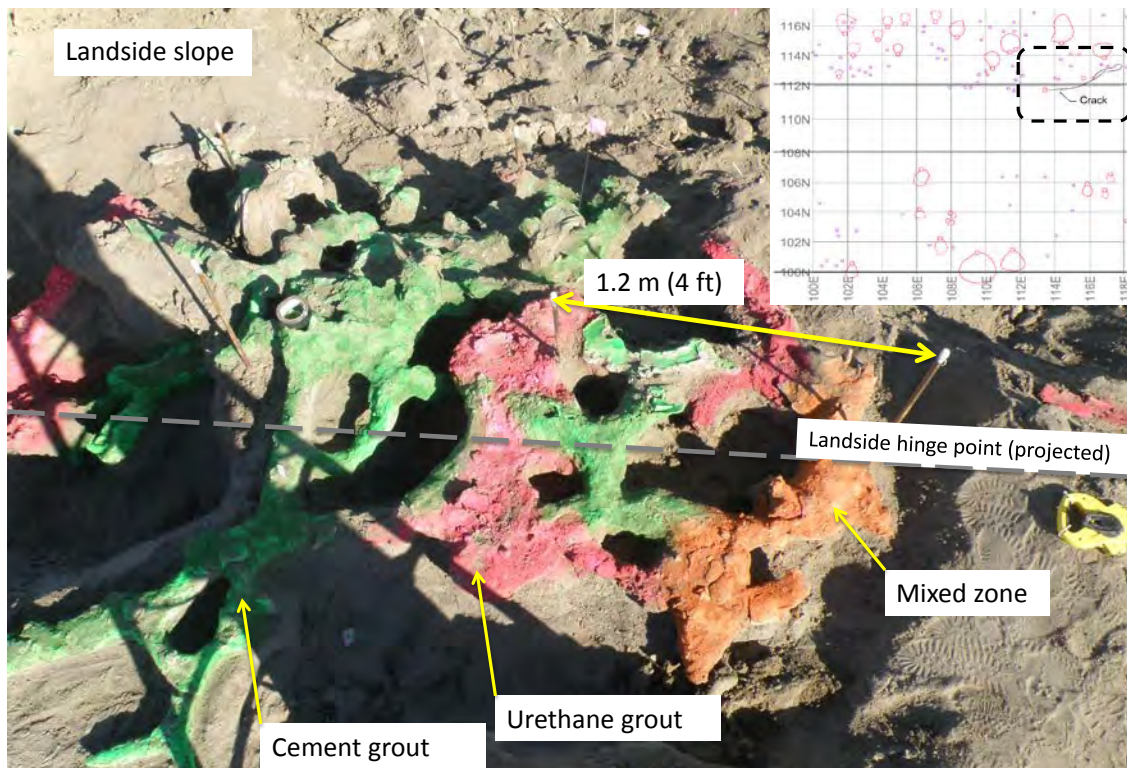
The colored grout on Figure 5-5 indicates a large portion of the complex was filled with cement-bentonite grout (green color), and several large pieces were filled by the polyurethane grout (pink color). Several additional polyurethane injection ports were installed in this area with the objective of effectively filling all voids; however, some of these ports were inadvertently pushed through the already hardened cement-bentonite grout, causing it to break and allowing polyurethane to flow through the cracks and generate a mixed grout area, colored with orange spray paint (right edge of burrow complex).

Figure 5-5. Aerial view of east edge of main complex near landside edge of crown

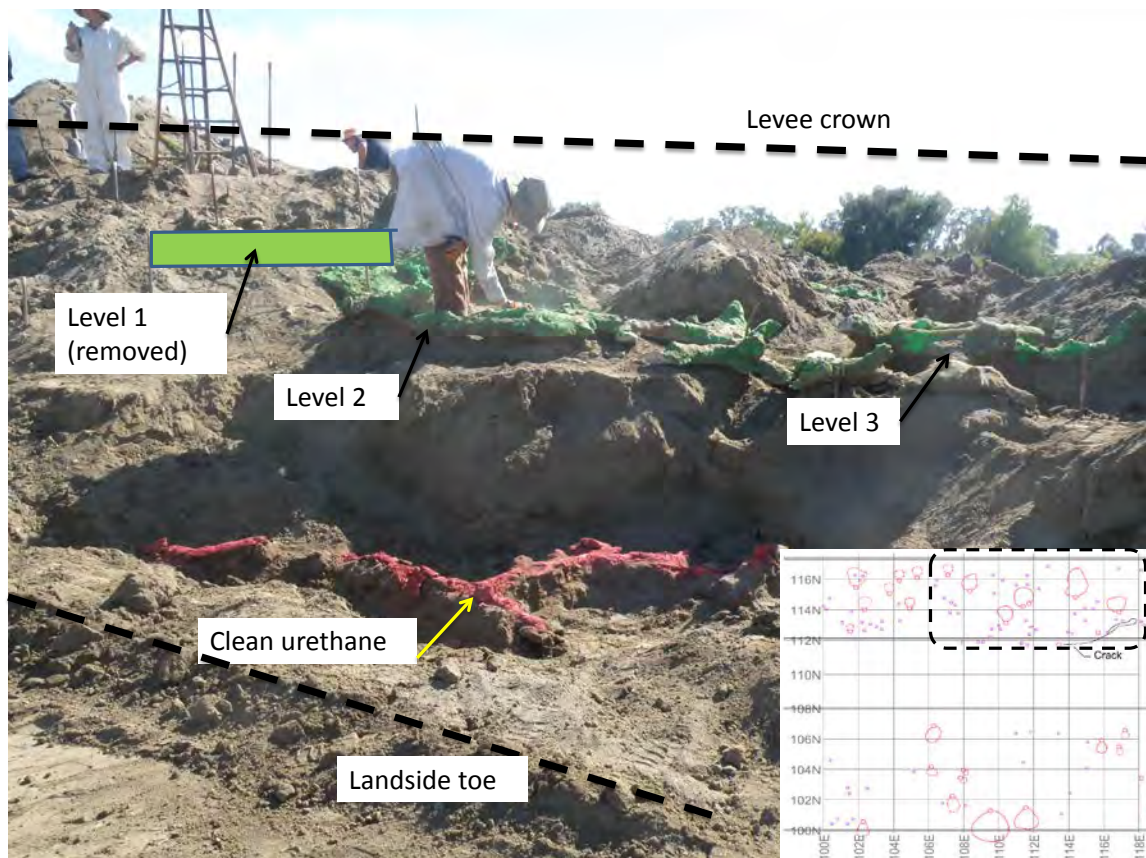
The perspective shown in Figure 5-7 allows defining three distinct levels of the landside burrow system: (1) the shallowest portion of the complex coincides with the very dense and intertwined zone previously described, which connected all the cement-bentonite grout injection points; (2) a deeper level, where the system of burrows is composed by two main tunnels, and (3) a single tunnel that sharply rises to an elevation similar to level 1. An isolated burrow grouted exclusively with polyurethane was observed near the landside toe (bottom of Figure 5-7); approximately 1.5 meters (4.9 ft) below level 2 of the main complex and extended 2 meters (6.6 ft) parallel to the levee alignment, with a sharp turn towards the interior of the levee.

Figure 5-7. Lateral view of landside levee slope burrow system

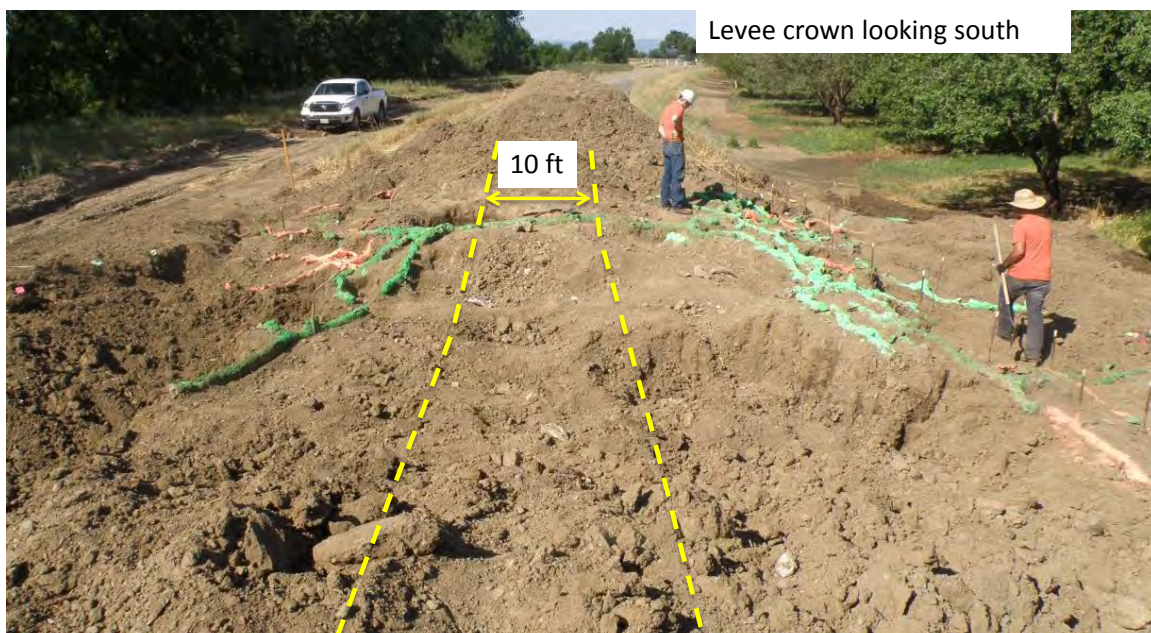
Figure 5-12. View of completely penetrating burrow

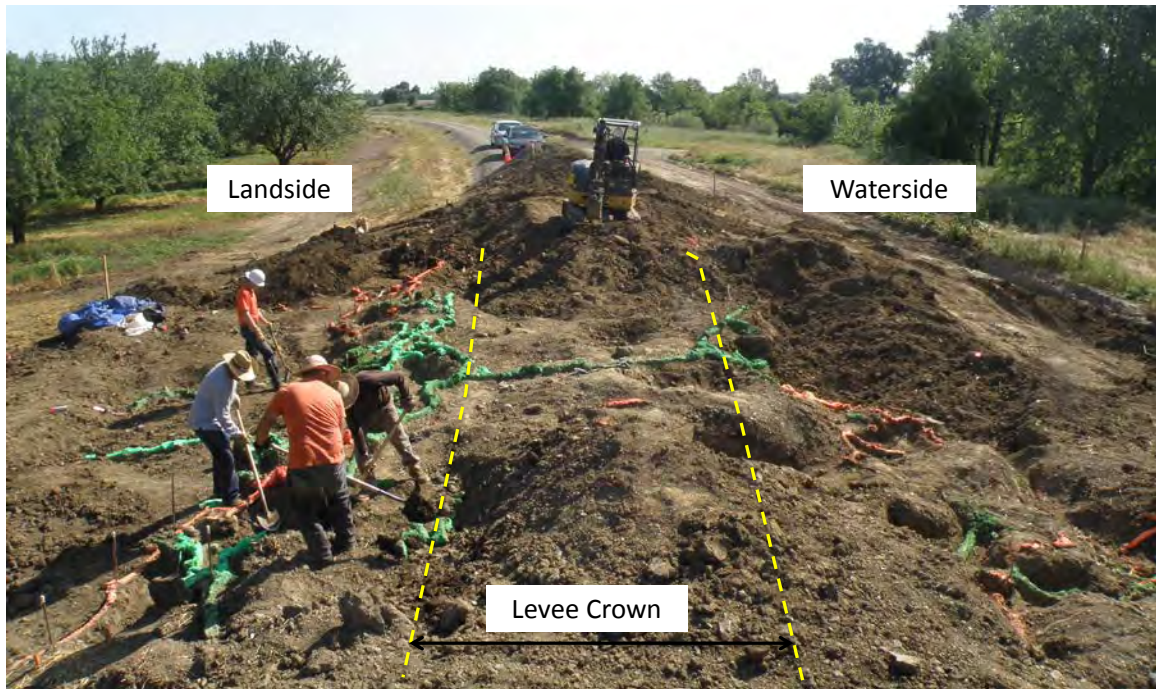
Figure 5-13. View looking north of completely penetrating burrow

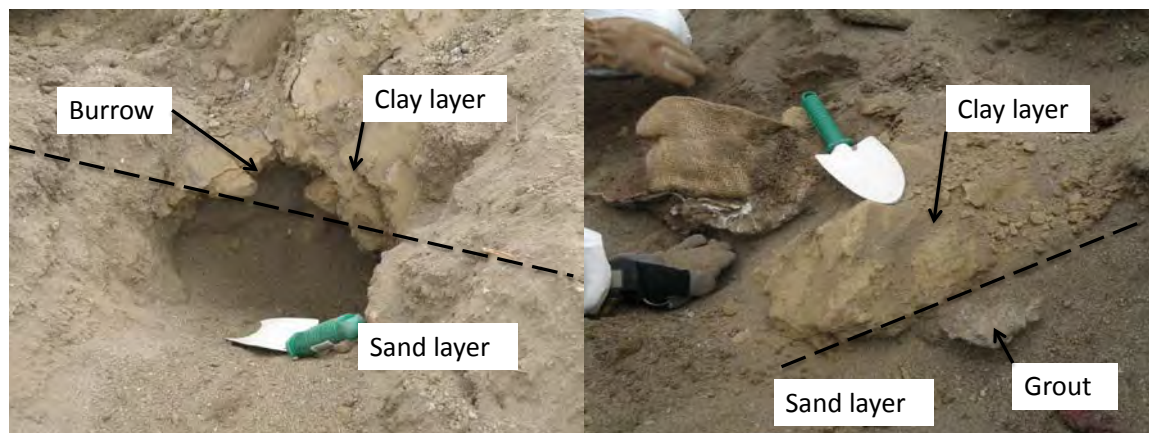
Layering and soil type was also observed to have a strong influence on the amount and extent of burrowing on the sandy levee. Figure 7-1 shows two instances where the burrows follow an interface between a stiff fine-grained or cemented sand layer overlying the loose sand material composing most of the embankment, most likely because the animals prefer to dig through the loose materials, while at the same time having a stiff and stable roof. This was the case for most of the burrows observed on the sandy levee as well as other sandy levees. Several other burrows were encountered exclusively along the stiff fine-grained layers in the levee embankment. Similarly, Harder et al (2012) investigated root penetrations into a slurry wall and found a ground squirrel burrow penetrating the slurry wall from the crown of the levee and extending several feet below the crown along the interface of the slurry wall and surrounding sandy embankment.

Figure 7-1. Layer interface facilitating burrowing in the sandy levee.

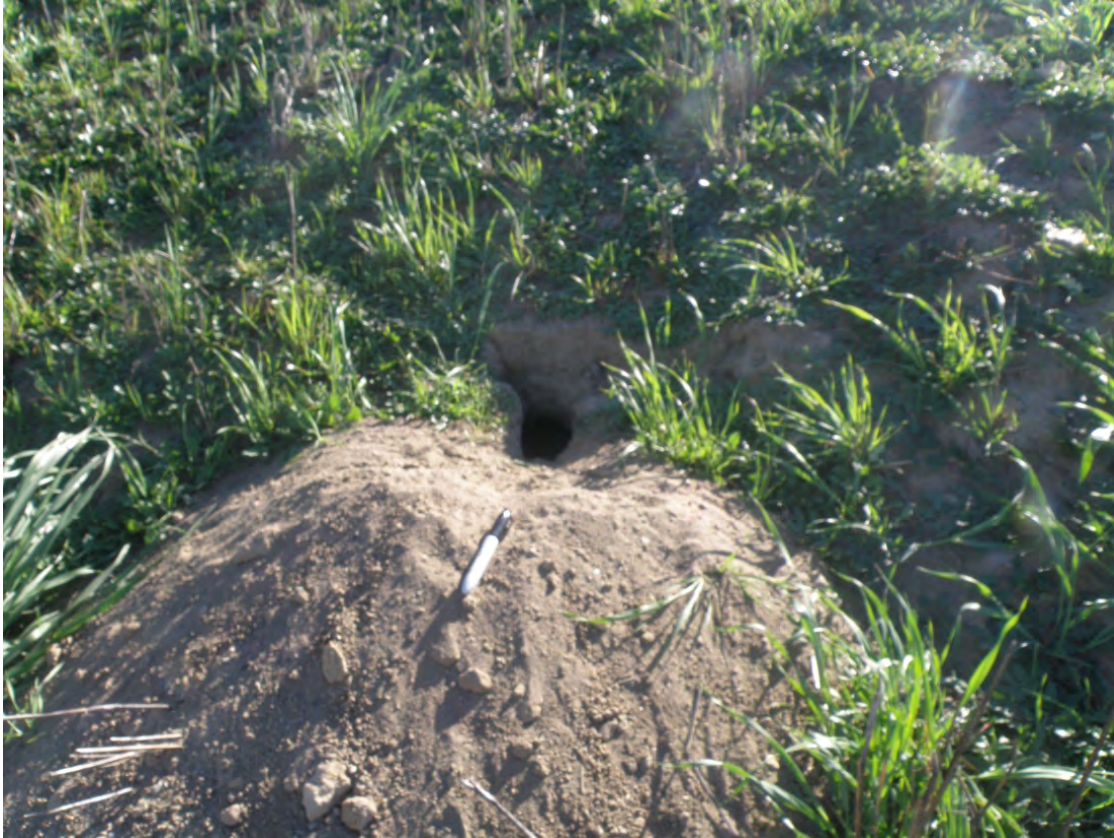
Figure 7-2. New burrows on landside slope of the reconstructed sandy levee

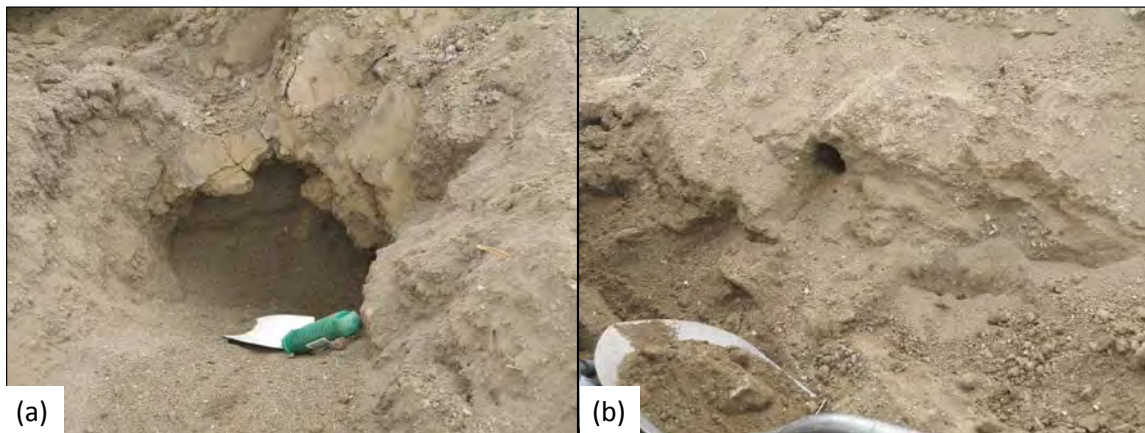
Figure 7-3. UngROUTED burrows in the sandy levee: (a) A burrow near Level 1 of the large landside burrow complex, and (b) An ungrouted burrow to the west of the same complex

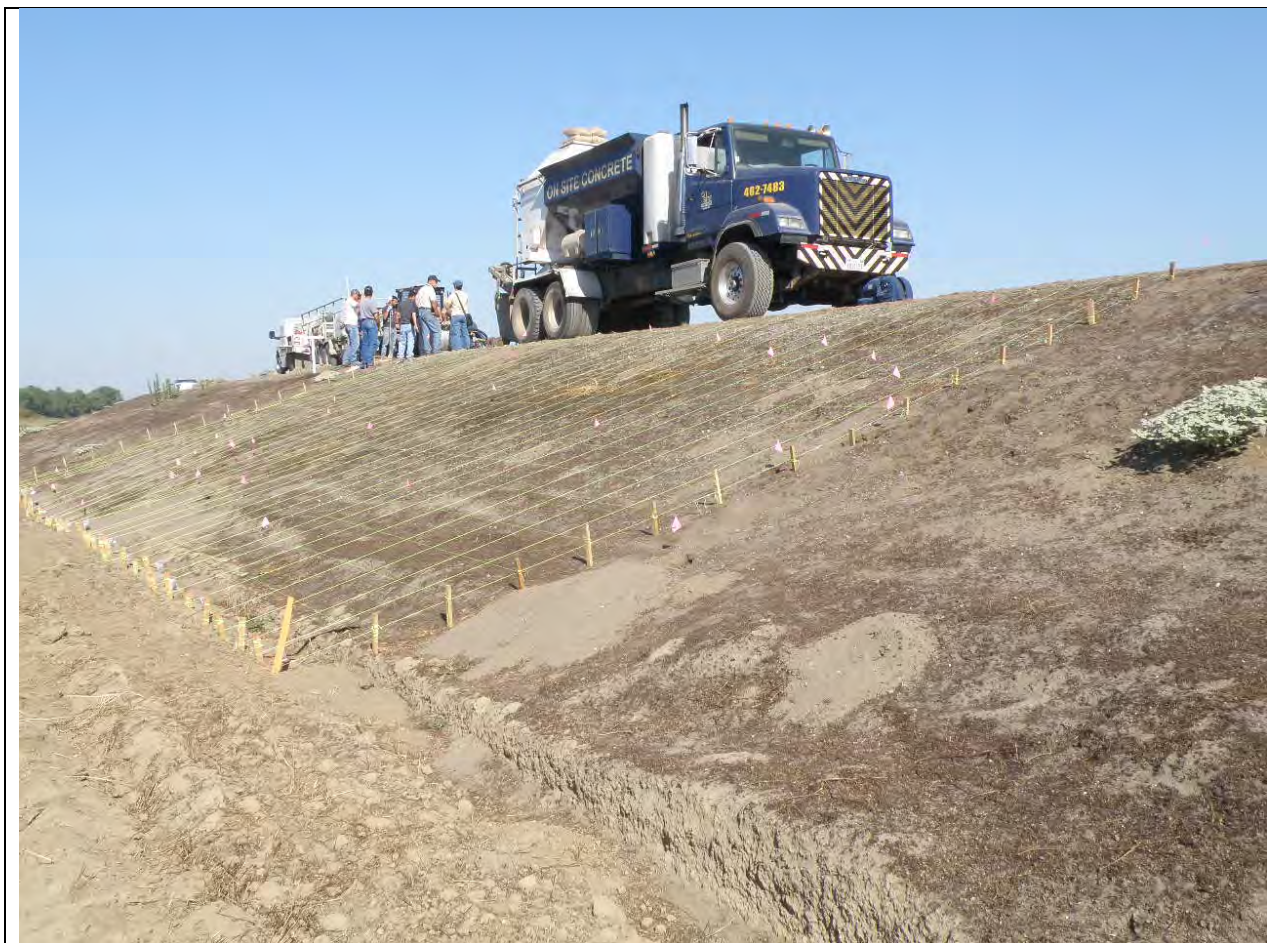
Photo 4A-1. View of test area waterside slope on the sandy levee. Grid spacing 0.5 m. Large mounds of sand near the lower corner of the grid are two active ground squirrel burrows.

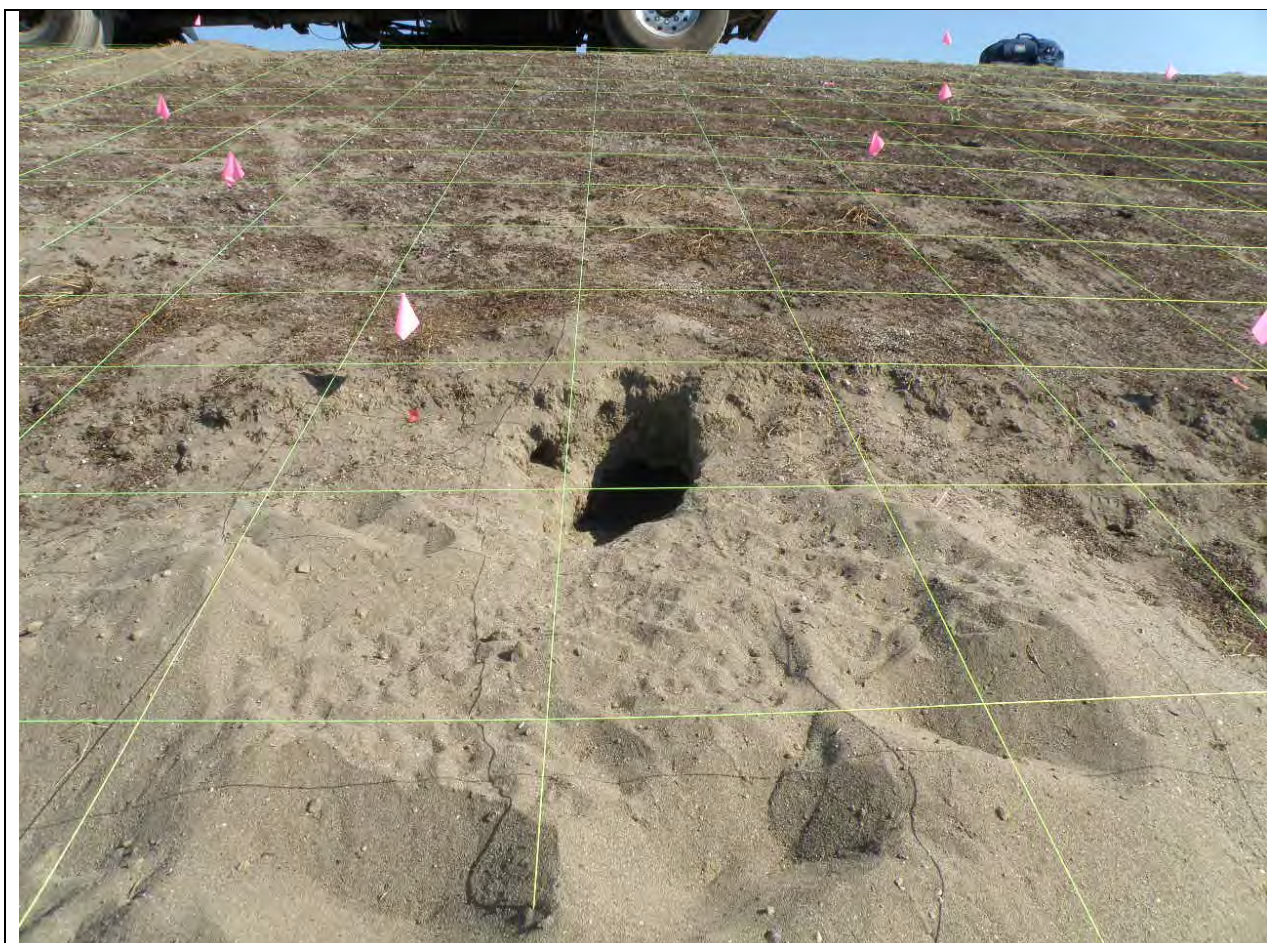
Photo 4A-2. Close up of large active ground squirrel burrow near waterside toe of the sandy levee. Grid spacing 0.5 m. Small footprints can be observed on the ejected sand cone, suggesting recent activity of the burrow. Pink flags represent other burrows surveyed on the slope surface.

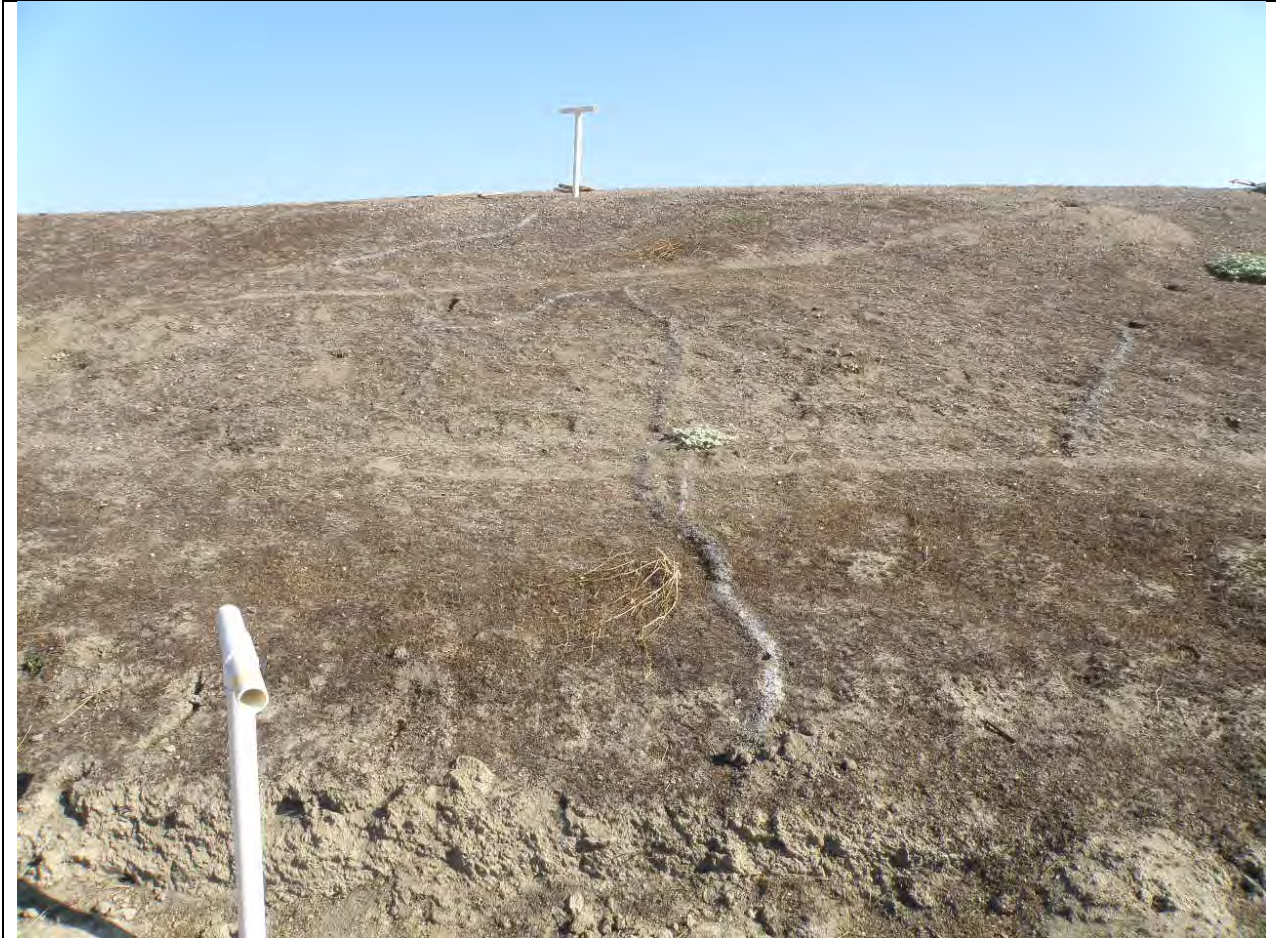
Photo 4A-3. Gopher burrows along waterside slope surface of the sandy levee. White PVC pipes were used as references for the T-Lidar scans.

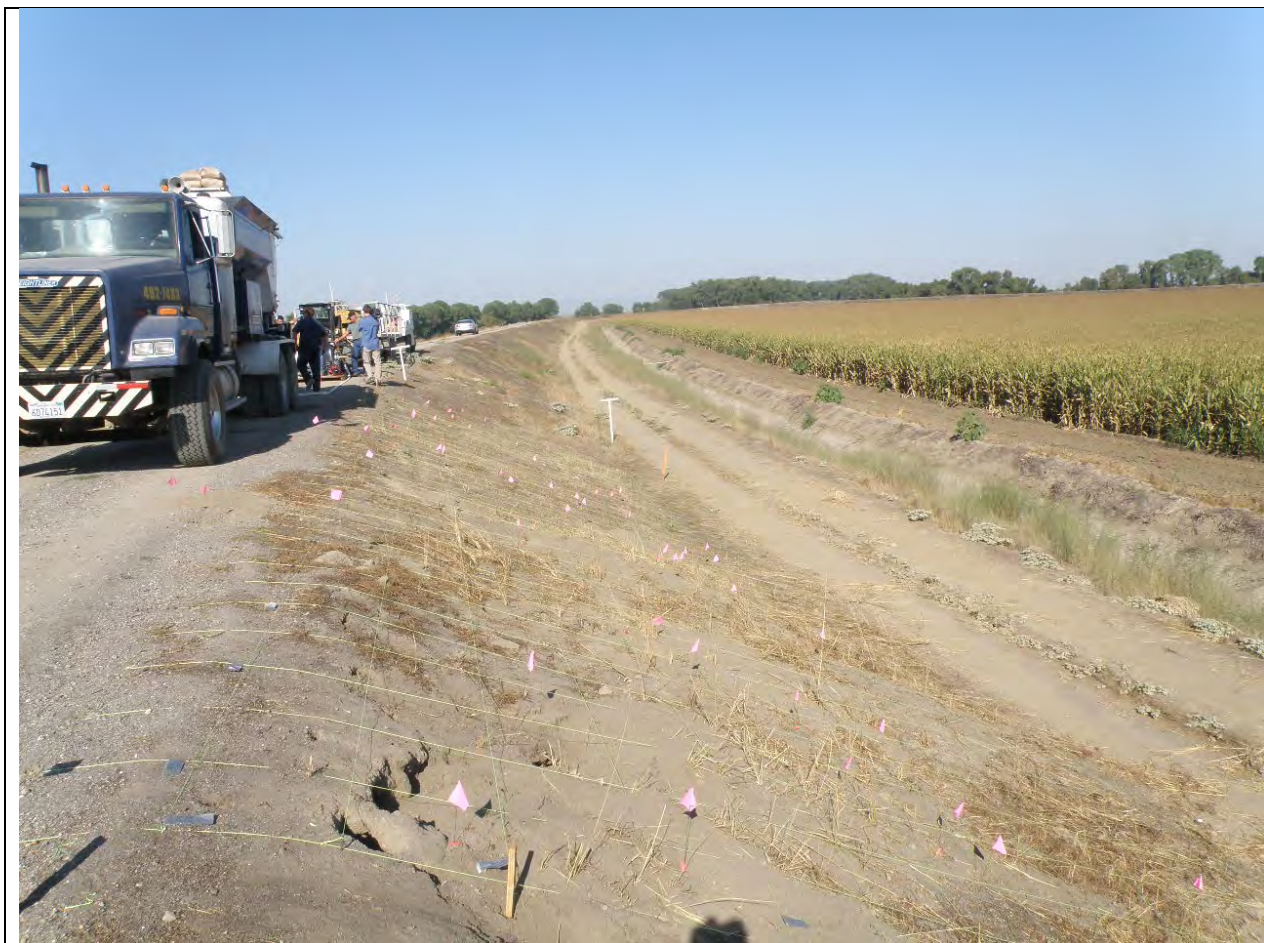
Photo 4A-4. View of test area landside slope, sandy levee. Grid spacing 0.5 m. Corn crop to the right of the image is likely the food source supporting the ground squirrel population. Even though there is a ditch near the landside toe, the levee segment has a series of wooden planks that allow passage of the squirrels. Corn kernels were observed a ground squirrel burrow entrance.

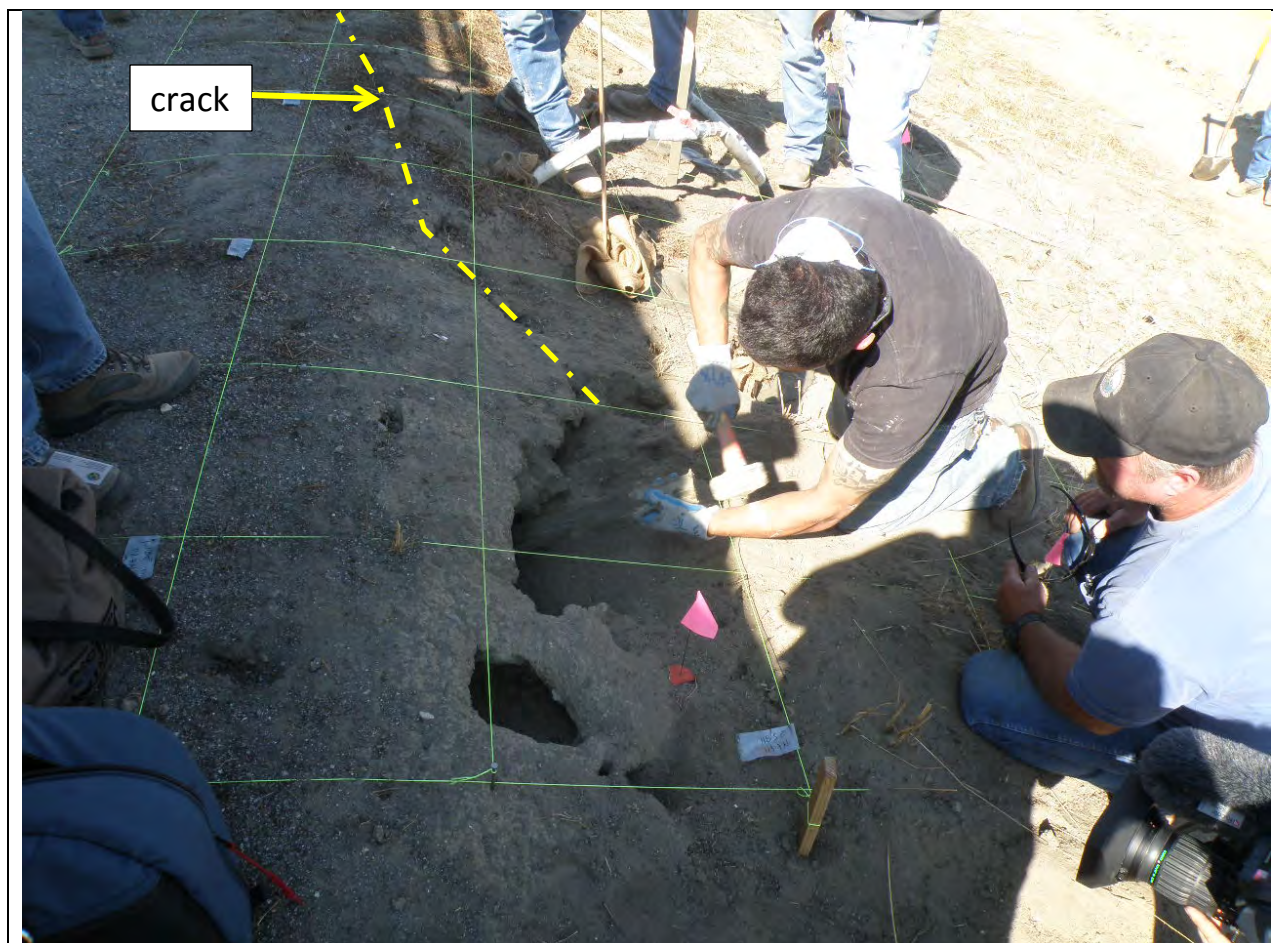
Photo 4A-5. Landside levee hinge point, DWR injecting cement-bentonite grout into large burrow cavities. A crack had formed between these holes and extended several meters towards the levee centerline.
